Ohio Karst

Douglas Aden
Ohio Department of Natural Resources
Division of Geological Survey

Mapping Locations

Delaware Study Area

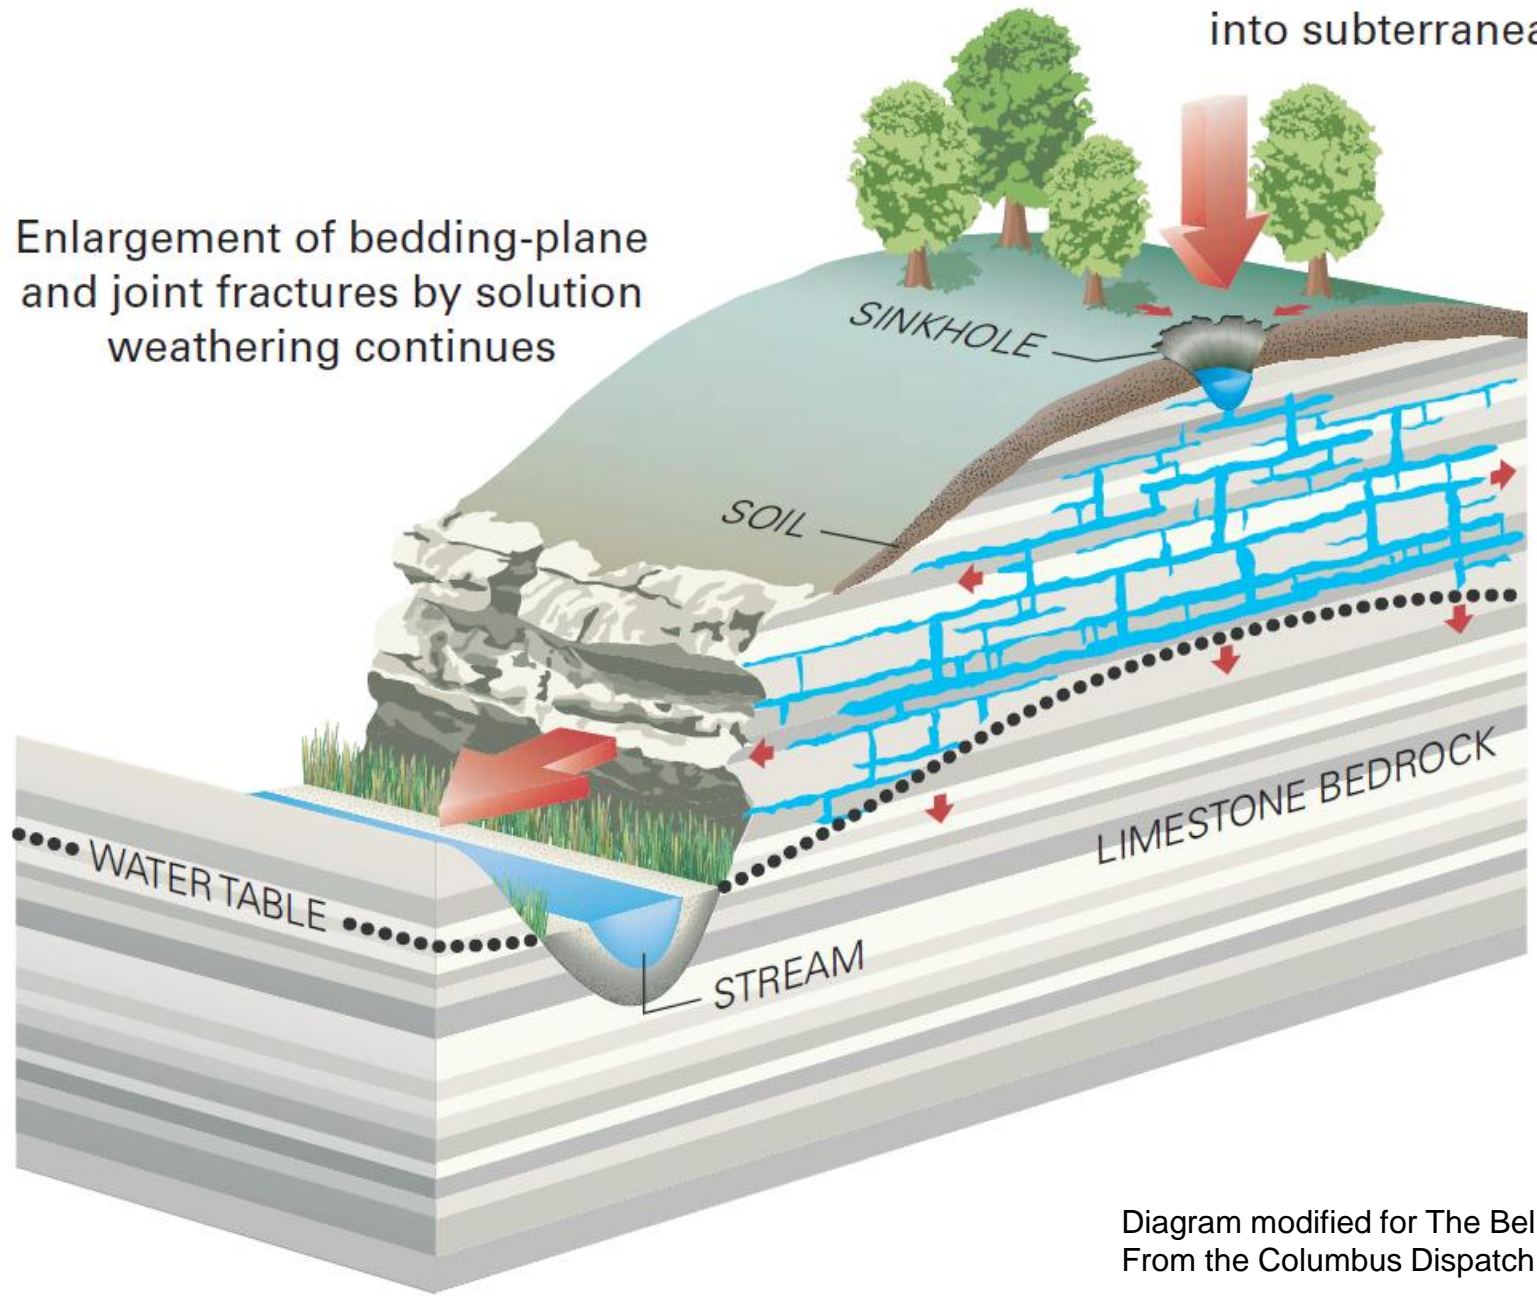
Sinkhole forms where soil and limestone rubble subside into subterranean voids

Enlargement of bedding-plane and joint fractures by solution weathering continues

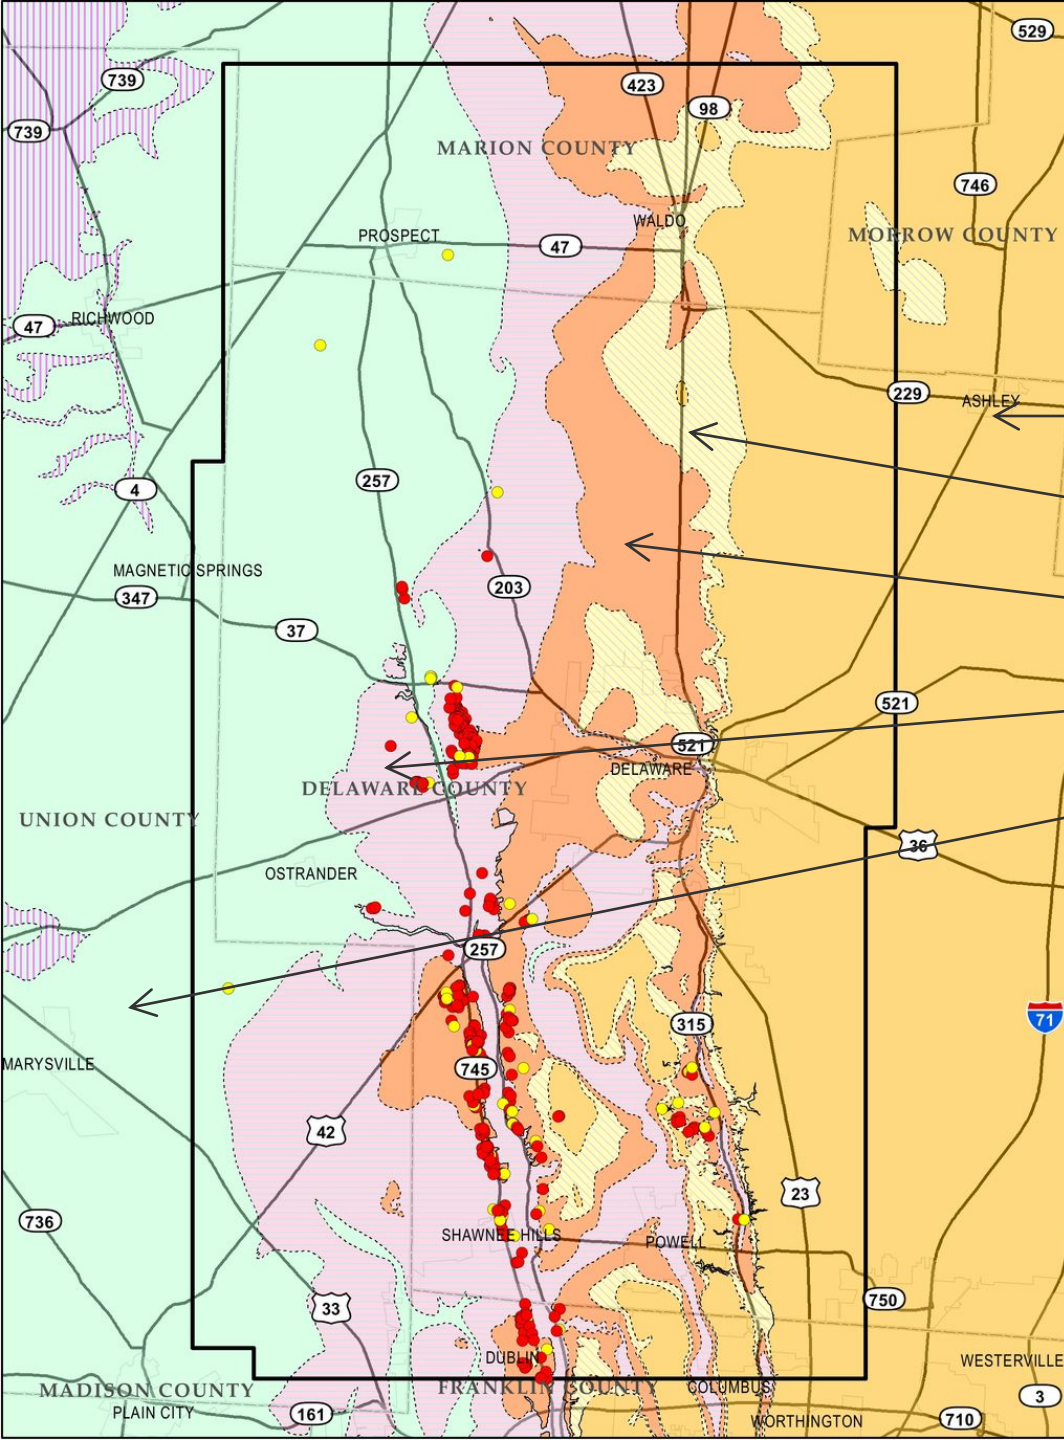
Bedrock geology

Ohio Shale

Olentangy Shale

Delaware Limestone

Columbus Limestone

Salina Undifferentiated

Sinkholes located
in limestone

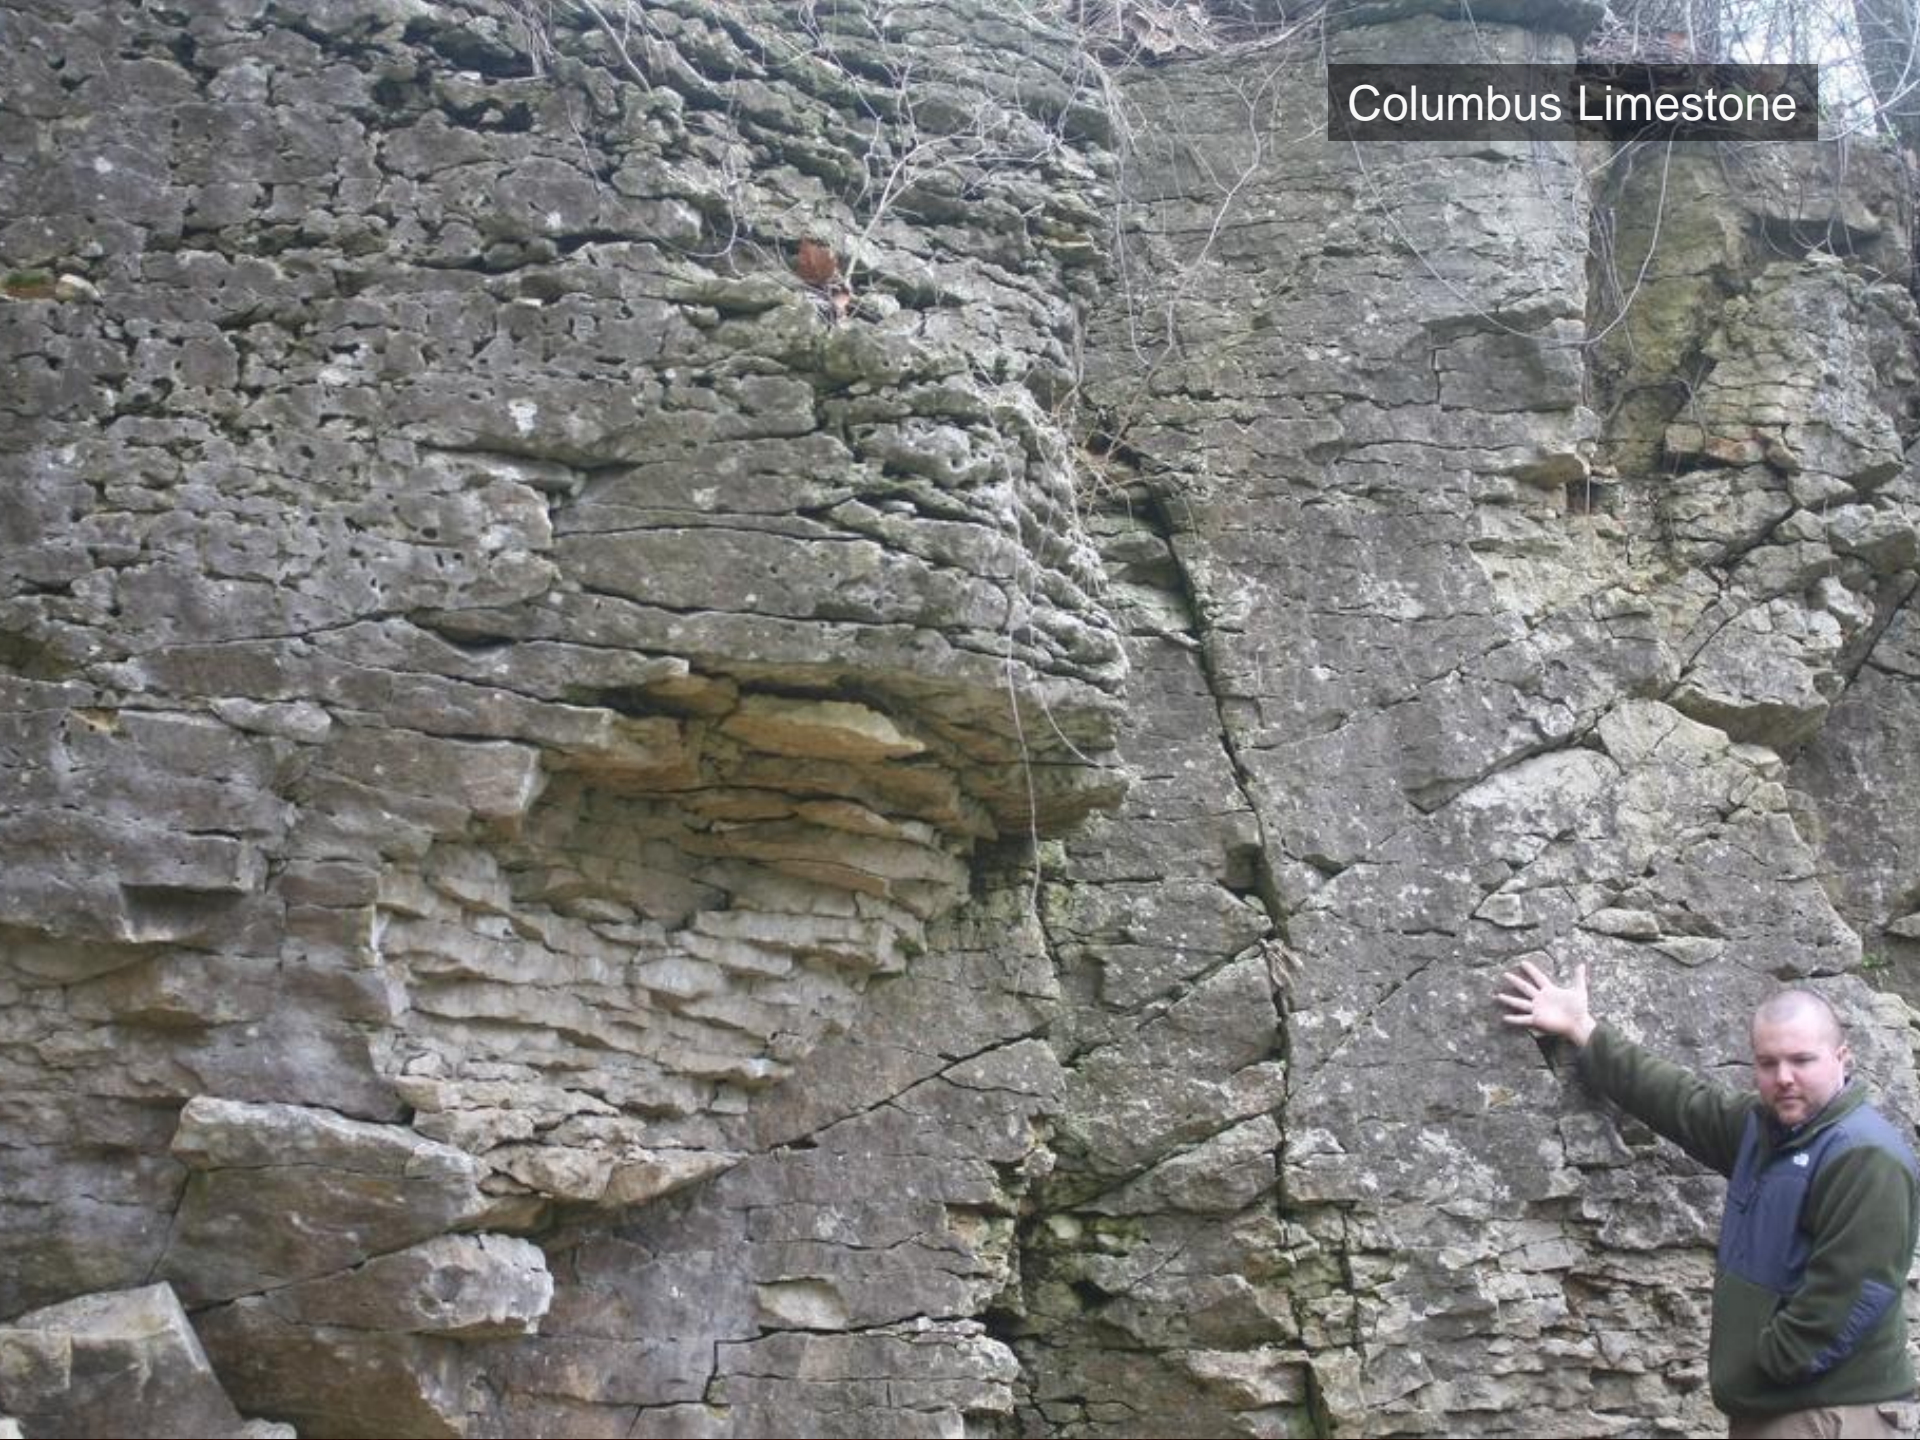
Drift thickness

- Sinkholes concentrated in areas of thin glacial till

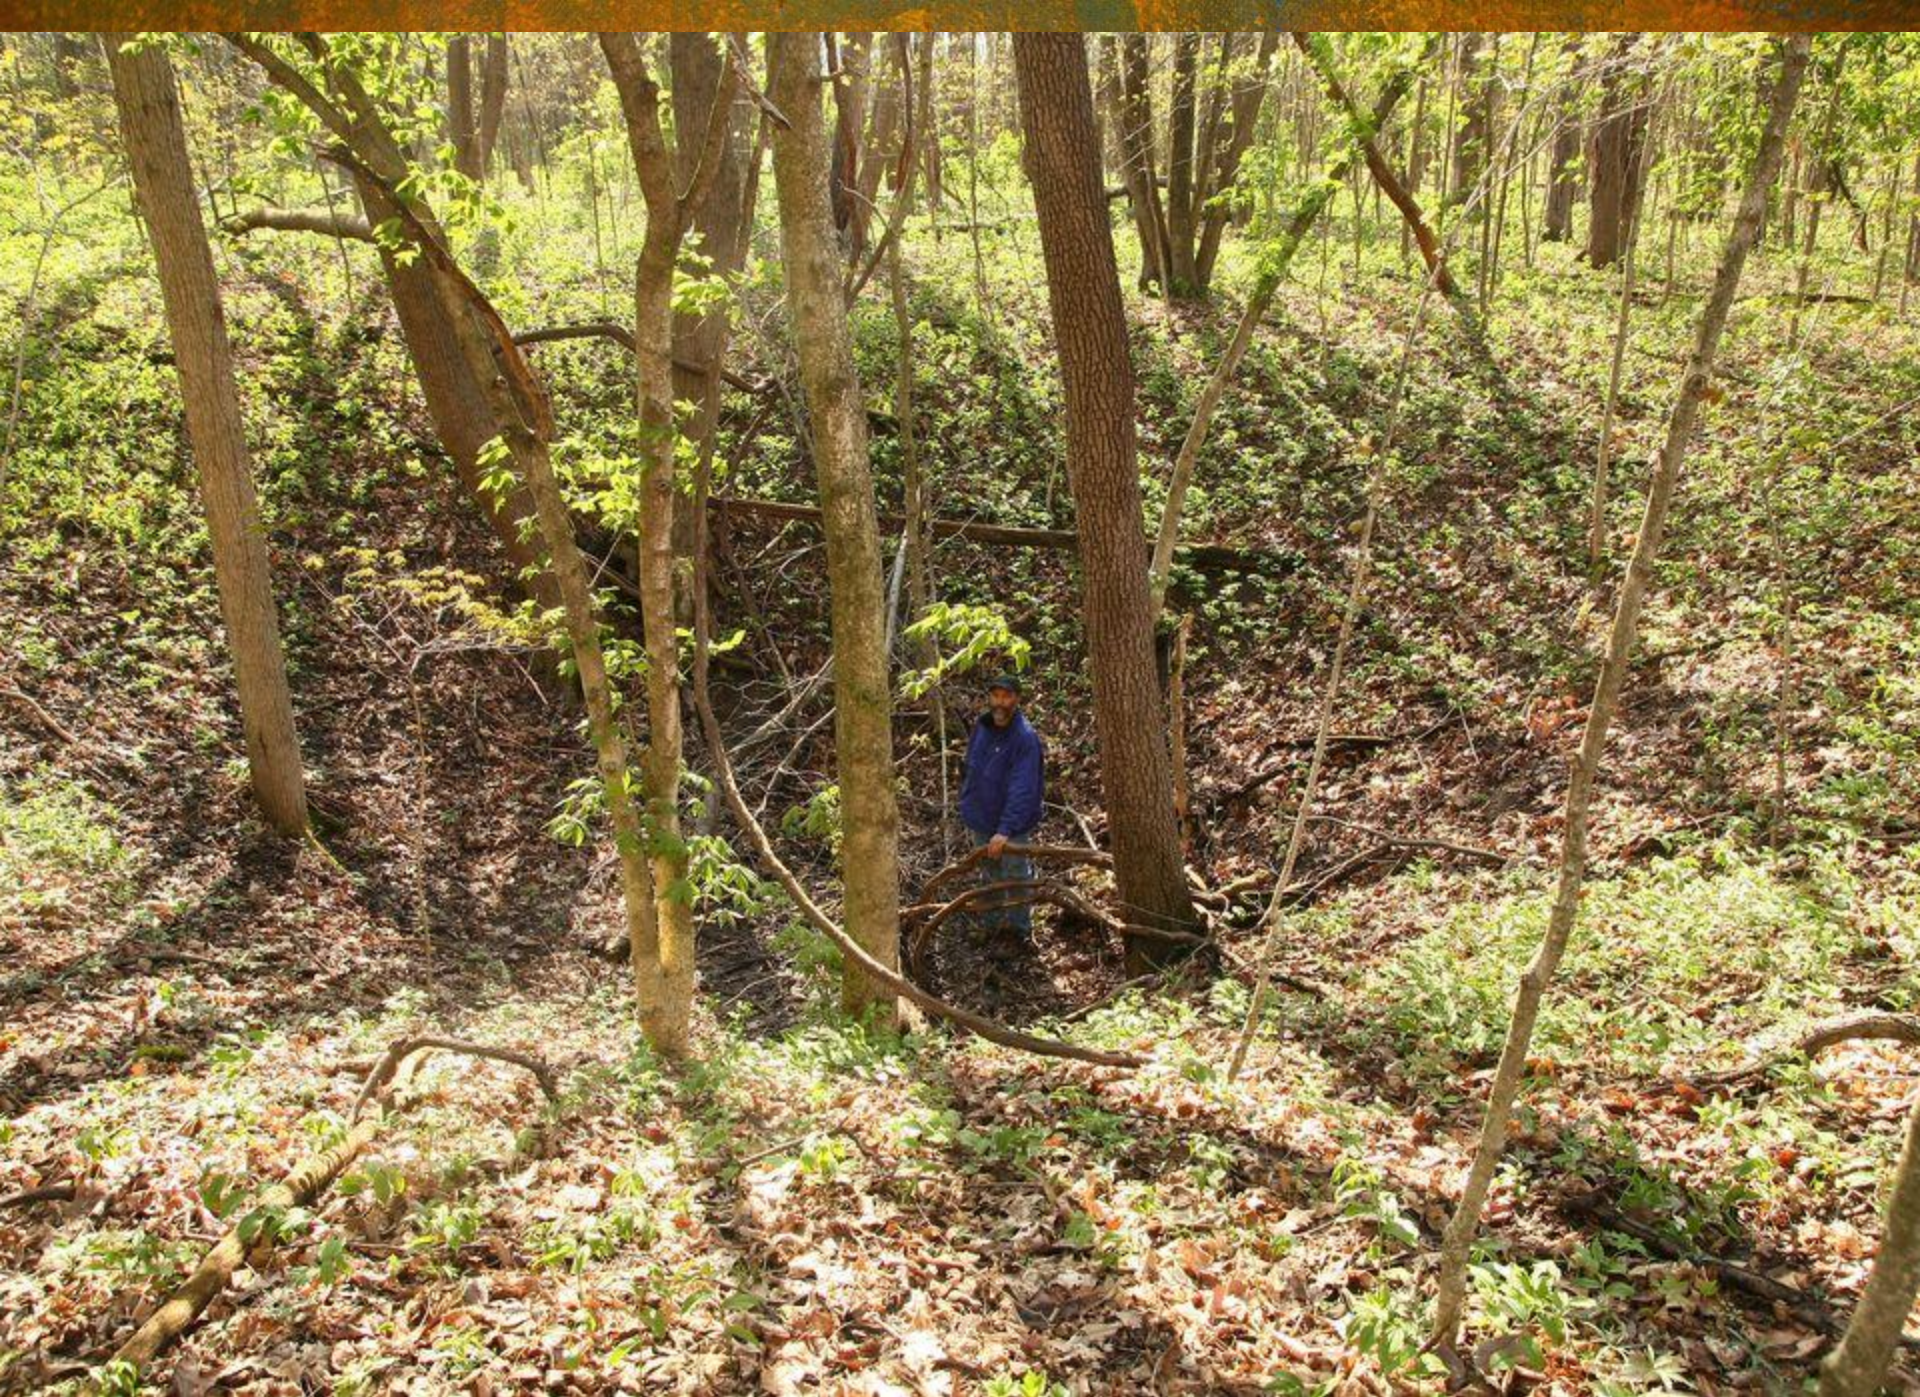
1988 ■ Photos can monitor growth over time

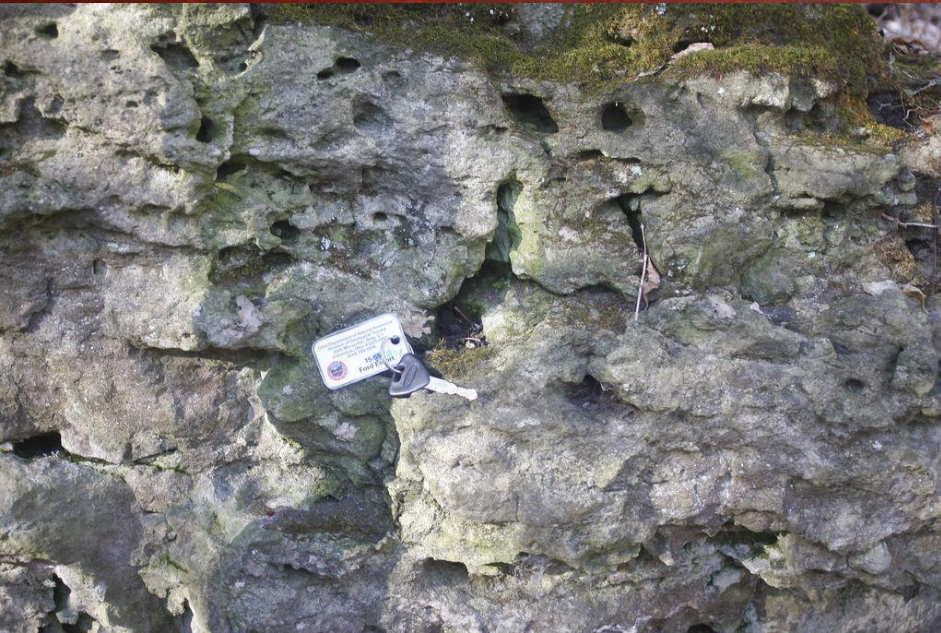
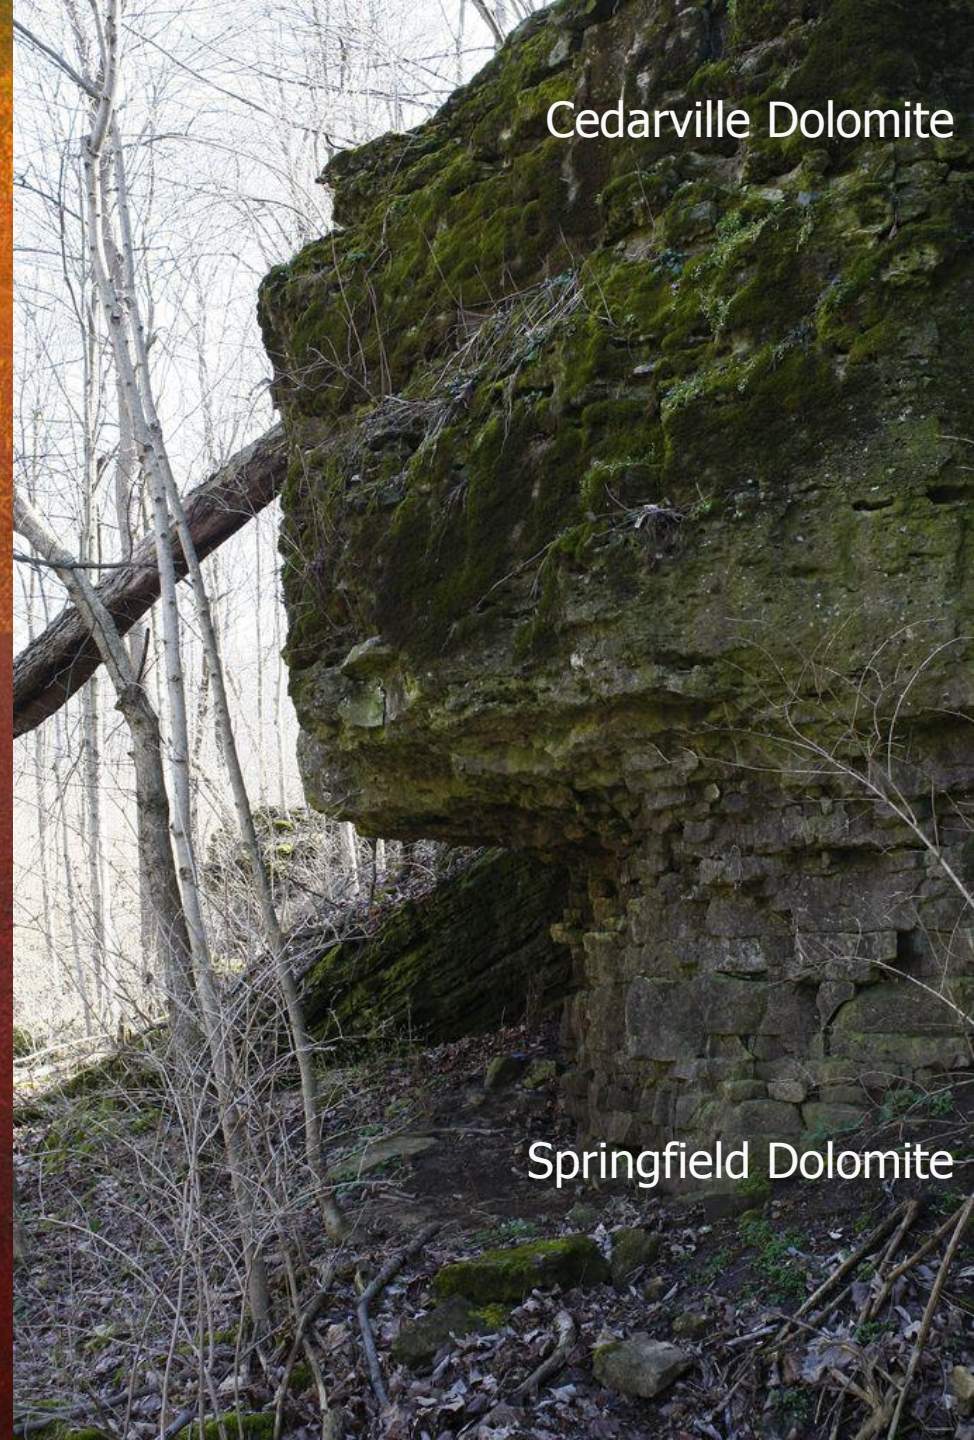
Karst forming units

- The contact between the blocky Cedarville Dol. and the fractured Springfield Dol.

Cedarville Dolomite

Springfield Dolomite

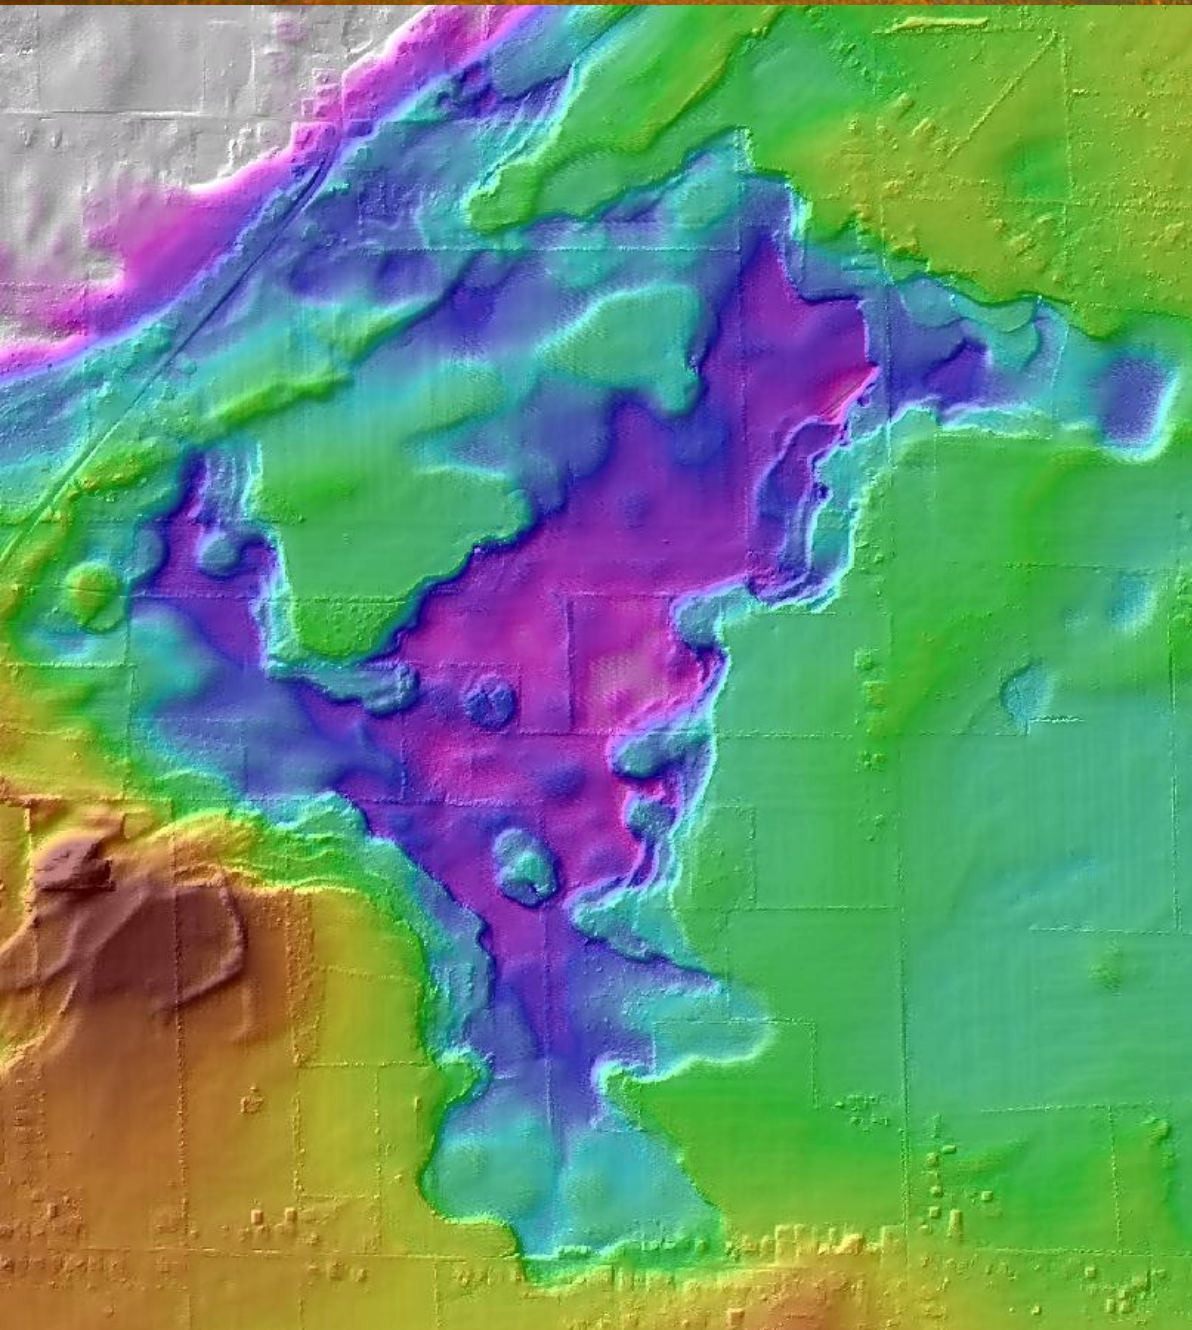
- Largest sink in Ohio
- 7100 feet from north to south
- Spillover ~21ft
- Some lows 35ft deeper than the adjacent upland
